# 1972 Fender Stratocaster

Maple Neck Refret, Finish Restoration, Conservation Cleaning, COA, and Final Setup Addendum

| Prepared by | JR's Custom Shop Guitars, Torrance, California |

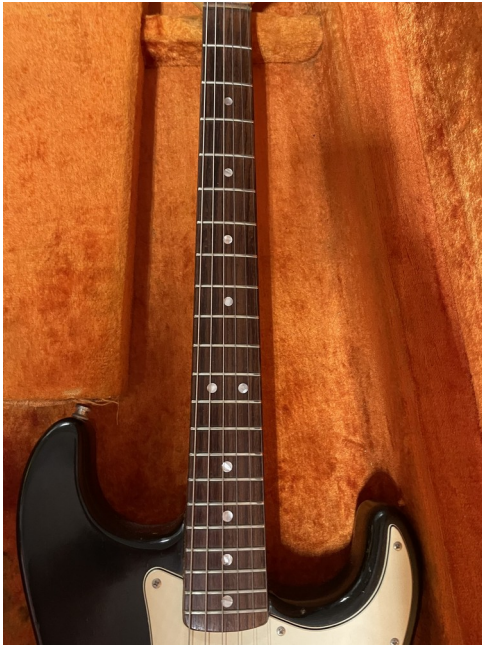
*Incoming configuration: black Stratocaster body received with a rosewood neck attached.*

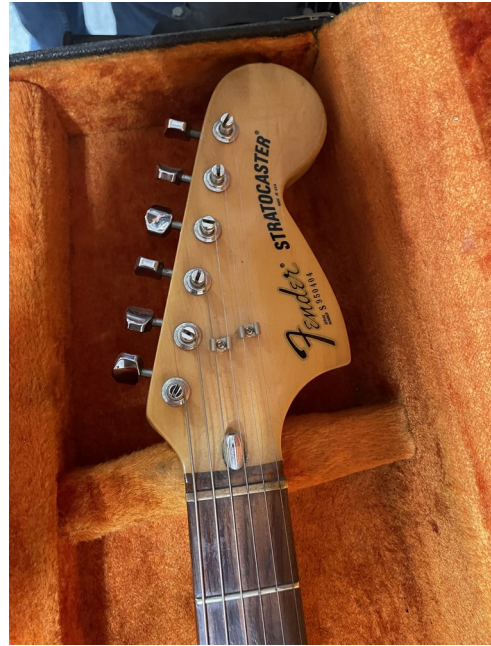
*Rosewood neck present at intake. The customer requested restoration of the original maple neck instead.*

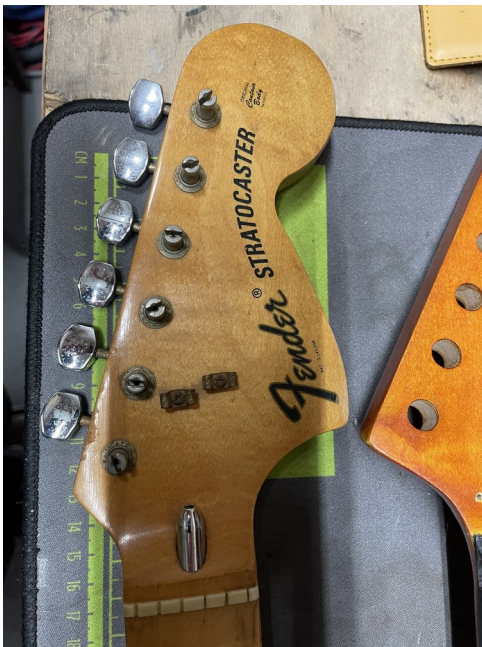
*Original maple neck before restoration, showing headstock, finish age, nut area, and hardware context.*

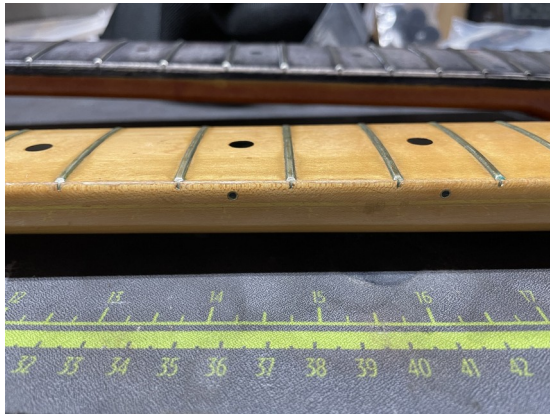
The existing fretboard finish showed aged poly buildup and wear, especially around the upper frets. The old frets and finish needed controlled removal/preparation instead of aggressive pulling.

*Maple board before refret, showing old frets and aged finish/poly buildup along the playing surface.*

After the old frets were out, problem poly buildup and fretboard humps were sanded down. The work focused on playability because the guitar is intended to be played, not merely displayed as a relic.

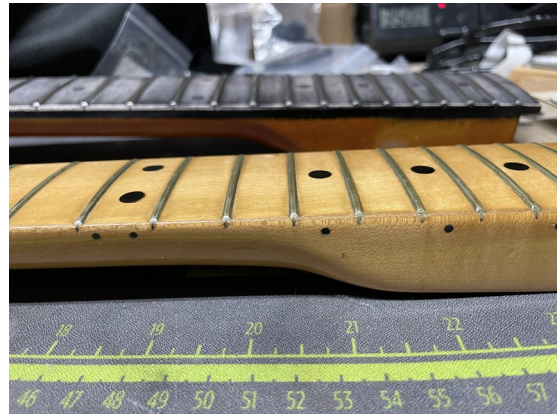
*Upper-board condition before fret removal and board correction.*

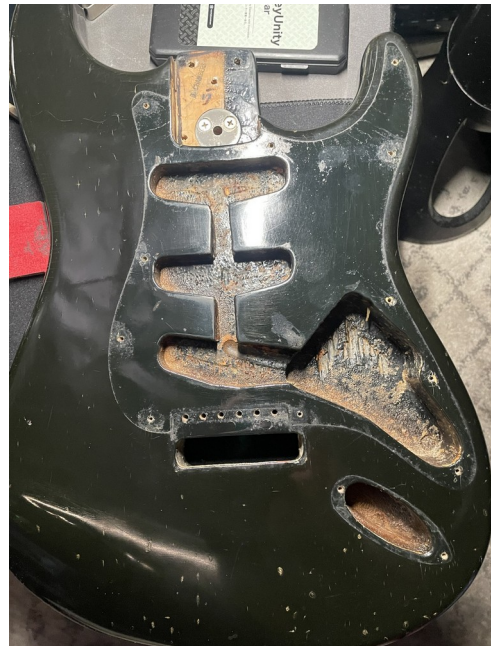
Old shielding was removed. It left brown residue and corrosion evidence consistent with long-term exposure and ocean-climate contamination.

*Old shielding and adhesive/residue after removal; corrosion/salt contamination was documented and cleaned.*

Electronics cleaner was used on caps, pots, pickups, and related contact areas before re-shielding. Salt residue matters because it can conduct electricity and accelerate failures.

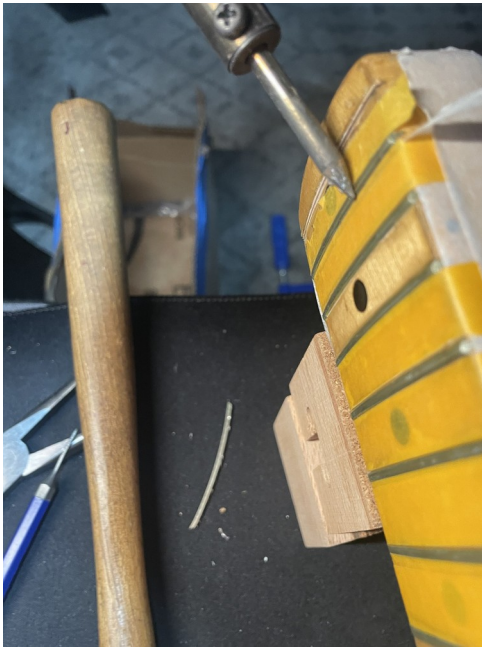
*Controlled fret extraction began with localized heat and support to protect the aged finish.*

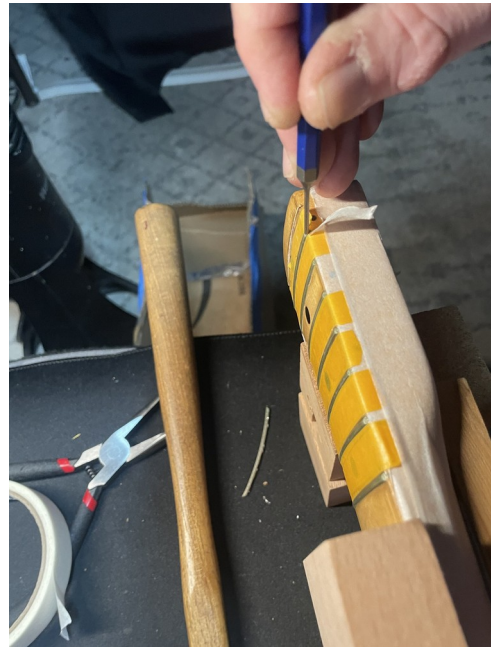
*Fret removal in progress using heat and a controlled push/punch technique to avoid chip-out.*

Frets were removed using heat and a controlled punch/extraction method. The process was intentionally slow to prevent the 1970s finish from fracturing into the wood.

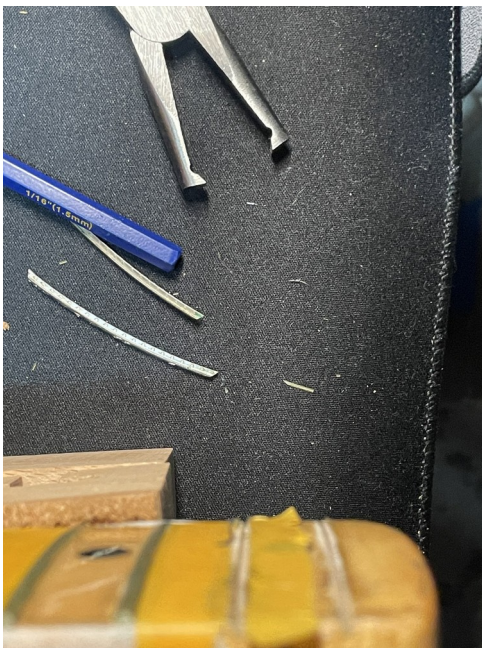
All old frets were removed with minimal poly chipping and no documented wood chip-out. This was the critical risk stage of the project.

*Removed fret section and protected fretboard edge; chip-out was kept minimal.*

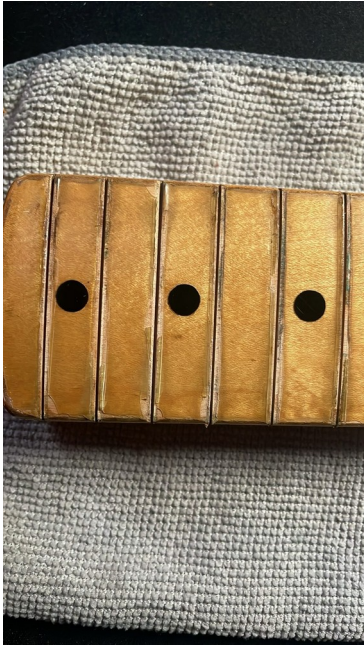
*Fret slots and board surface after removal, before final finish/slot preparation.*

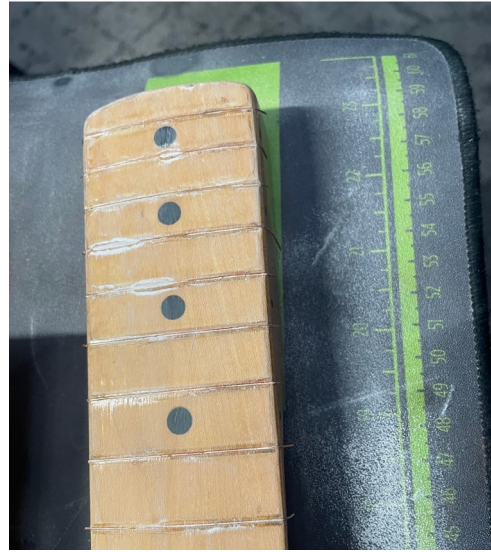
*Poly/finish leveling and board correction after fret removal.*

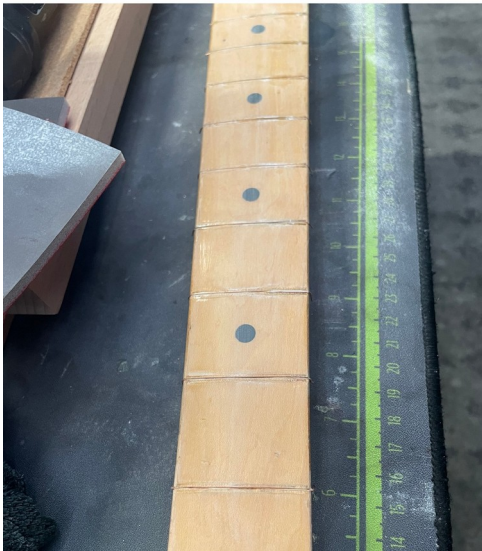
*Progressive sanding across the board to remove humps and prepare for a playable refret.*

The board and affected areas were progressively sanded through 320, 600, 1200, 2500, and 3000 grit, then cleaned before new poly was applied.
