# 2020 Fender Jim Root Jazzmaster

## Service Report & Repair Documentation

Prepared July 8, 2026

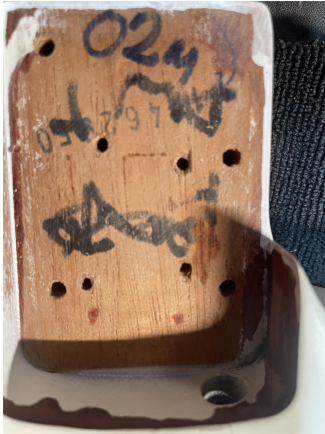
The neck was removed after a structural stress crack was observed near the neck pocket. The crack was verified as wood movement/structural cracking rather than cosmetic finish checking. The route/hole between the neck pocket and pickup

*Neck removed; neck pocket exposed for structural inspection.*

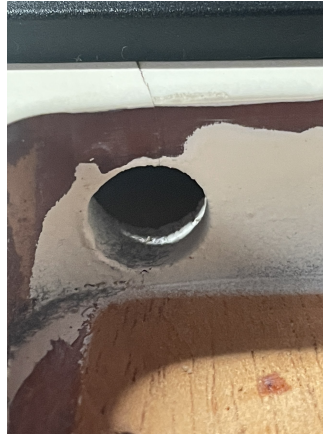
cavity was identified as the stress concentrator.

*Close-up of routed pocket passage and crack area before repair.*

Repair approach: the routed passage/hole was plugged with maple and Titebond to add material back into the compromised area and reduce further movement around the pocket.

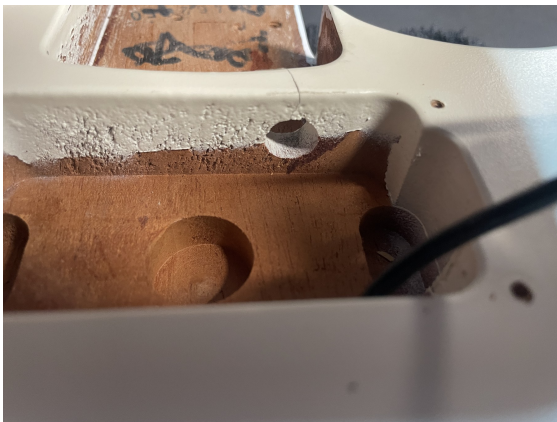
*Pocket/cavity opening documented during inspection.*

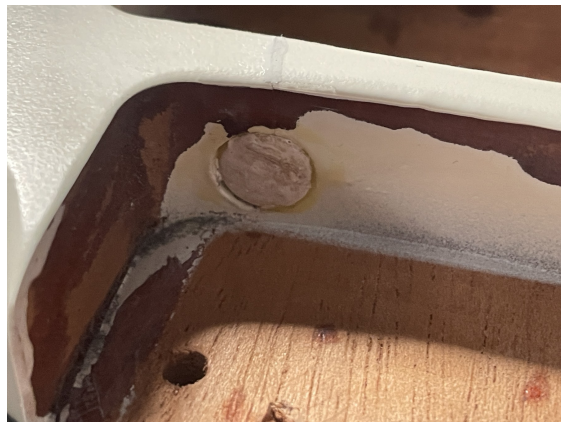
*Maple plug installed and glued into the compromised pocket area.*

| Item | Recommendation |
|---|---|
| Neck pocket repair | Monitor the stress crack area after seasonal humidity changes and after any future neck removal. |

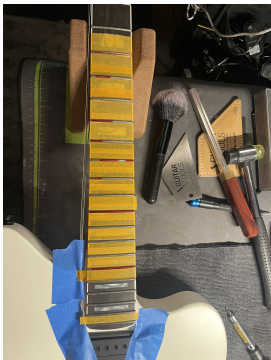
Fingerboard masked for fret work.

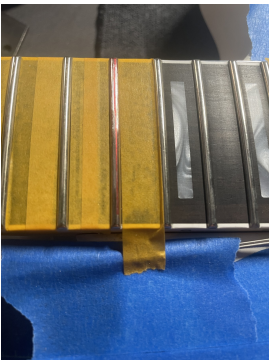
The buzz persisted when tuned down to D standard. The diagnostic pattern changed as individual strings were adjusted, indicating fret plane problems in addition to the nut slot. High and loose frets were identified, pressed in, glued down, and rechecked. Localized spot leveling, crowning, and polishing were then performed.

Localized fret leveling/crowning area documented.

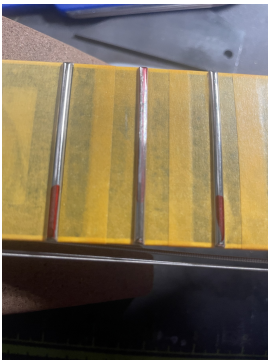
Spot fret correction and polish documentation.

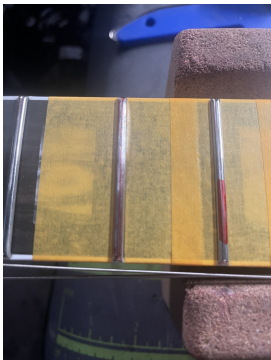
Upper-position fret correction documented.

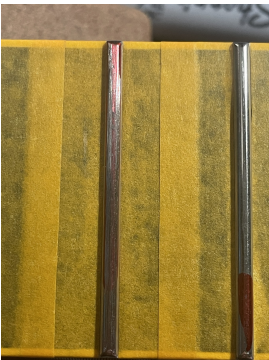
Close-up after localized fret dressing.

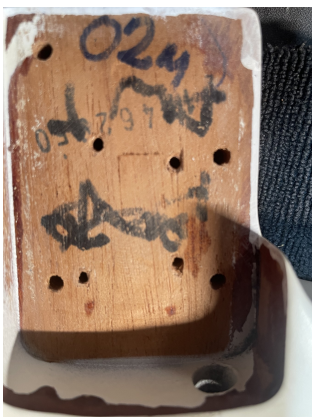
*Neck pocket with neck removed.*

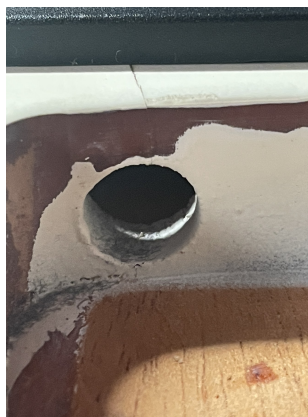
*Stress crack / cavity route area before plug repair.*

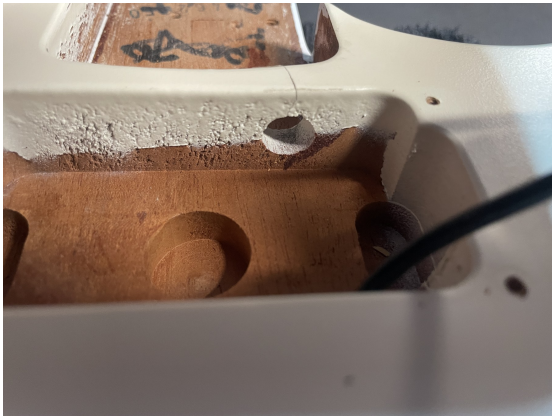
*Pocket/cavity route inspected.*

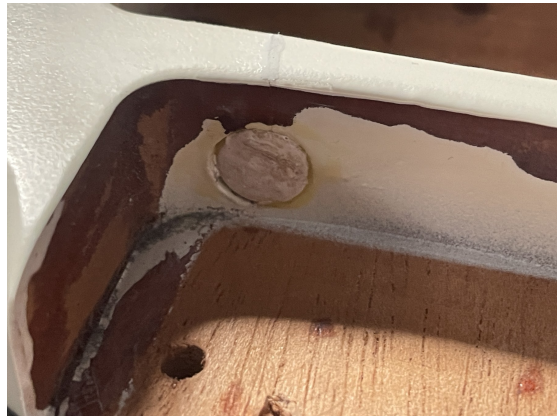
*Maple plug installed in pocket area.*

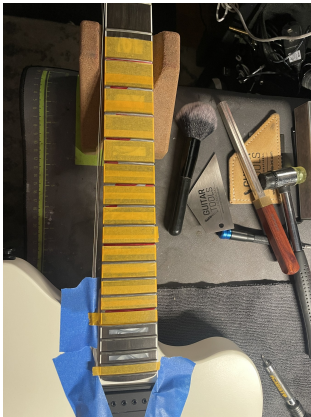
*Masked fingerboard before/while performing fretwork.*

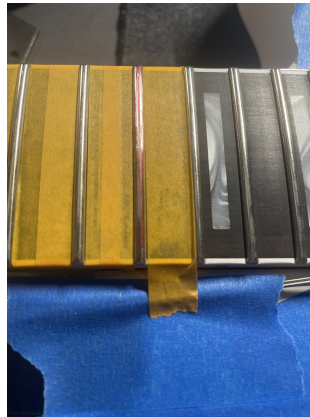
*Close-up of localized fretwork.*

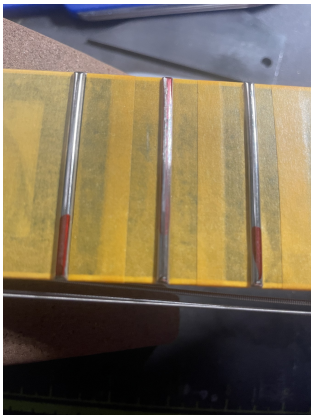
*Spot leveling/crowning/polishing documentation.*

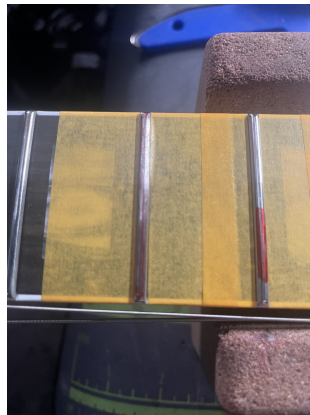
*Upper fret correction documentation.*

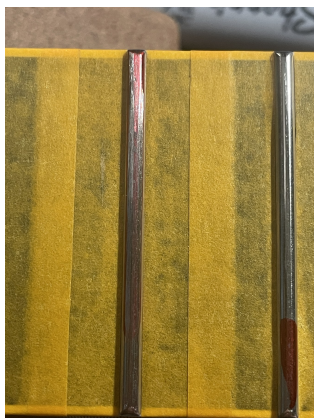
*Close-up of polished/corrected fret area.*
